LADWP Crews Act Fast to Repair Critical Transmission Tower

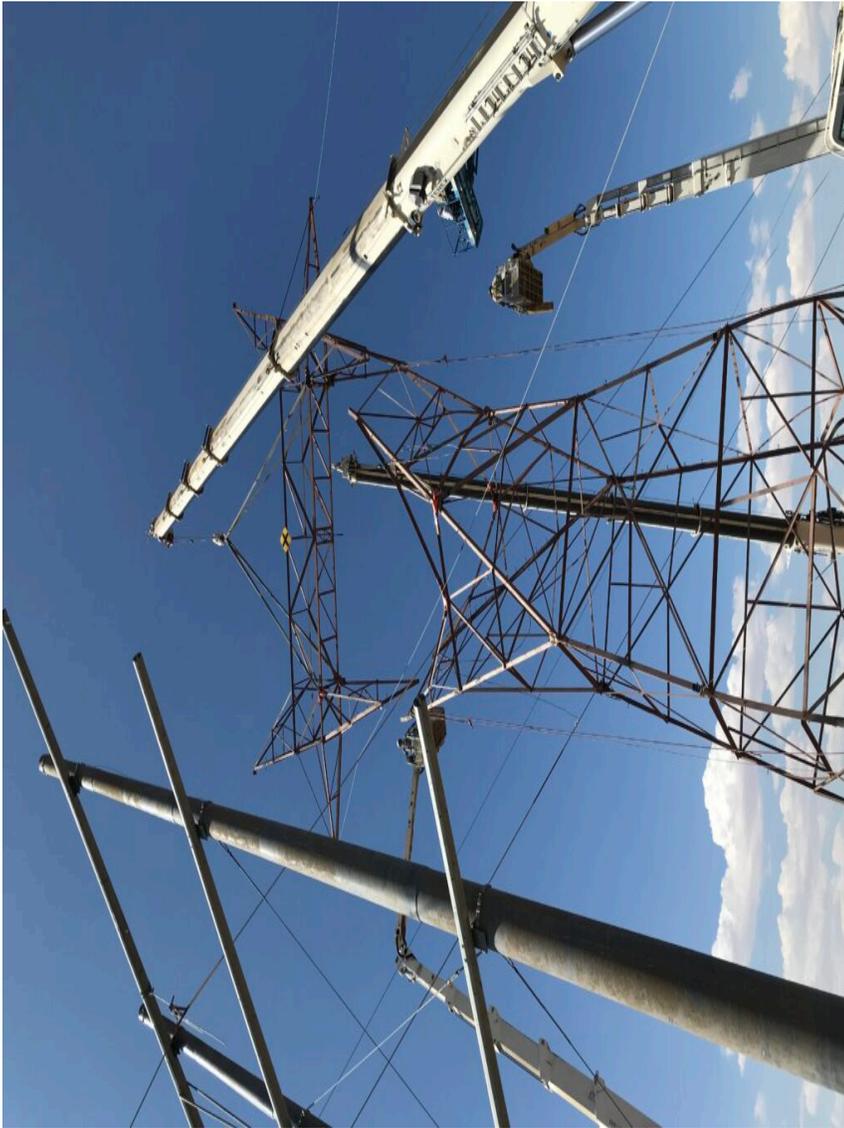
Temporary transmission tower to restore circuits. Photo by Graham Peace.

The repair work entailed stabilizing and securing the damaged tower, and building a temporary structure to support the conductors until a new permanent structure can be erected. For the temporary

tower, the crews used fiberglass poles that had been purchased for emergency restoration. The fiberglass poles offer greater mobility and ease of construction compared to traditional methods using guyed lattice temporary towers. The Victorville-Century lines were reenergized at 1646 hours on August 13, 2021—a mere eight days after the accident.
