LADWP Crews Act Fast to Repair Critical Transmission Tower

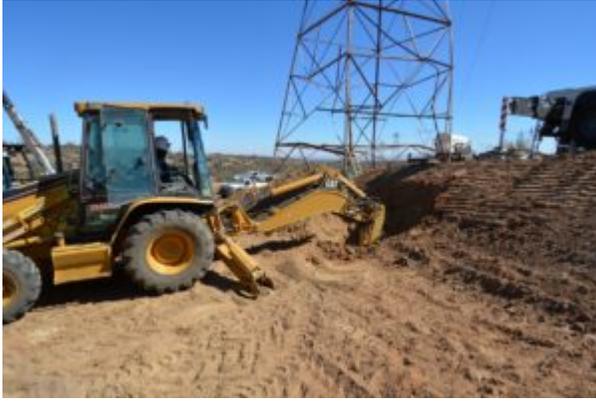
On August 5, 2021, LADWP's Transmission Construction and Maintenance Division was notified that a critical transmission tower supporting the Victorville-Century Transmission LT2 Line was severely damaged and leaning after being struck by a vehicle. An emergency response operation was conducted by Transmission, Construction and Maintenance, working collaboratively with several other LADWP groups and divisions, and the critical transmission line was re-energized just eight days later.

The tower was crippled when the vehicle crashed into a horizontal bar that ties two tower legs together. The Victorville-Century Lines 1 and 2 are critical high-voltage circuits that bring power to the Los Angeles Metro area from outside the city. Operating since 1936, they are part of the original Boulder Transmission Lines 1 and 2. Over the years those lines were renamed and divided into several circuits, forming a major transmission corridor between Boulder, Nevada and Los Angeles.

The repair work entailed stabilizing and securing the damaged tower, and building a temporary structure to support the conductors until a new permanent structure can be erected. For the temporary
