LADWP Crews Act Fast to Repair Critical Transmission Tower

By Carol Tucker

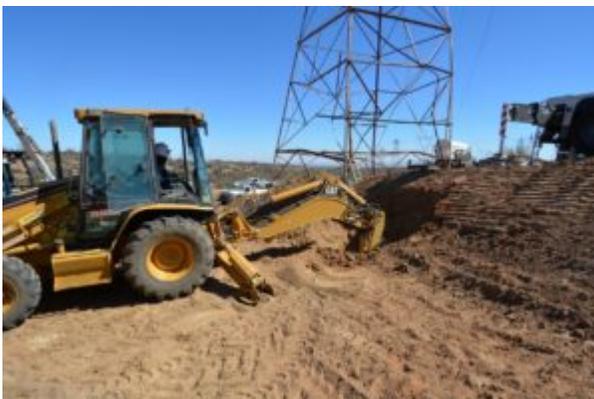
On August 5, 2021, LADWP's Transmission Construction and Maintenance Division was notified that a critical transmission tower supporting the Victorville-Century Transmission LT2 Line was severely damaged and leaning after being struck by a vehicle. An emergency response operation was conducted by Transmission, Construction and Maintenance, working collaboratively with several other LADWP groups and divisions, and the critical transmission line was re-energized just eight days later.

The tower was crippled when the vehicle crashed into a horizontal bar that ties two tower legs together. The Victorville-Century Lines 1 and 2 are critical high-voltage circuits that bring power to the Los Angeles Metro area from outside the city. Operating since 1936, they are part of the original Boulder Transmission Lines 1 and 2. Over the years those lines were renamed and divided into several circuits, forming a major transmission corridor between Boulder, Nevada and Los Angeles.

The repair work entailed stabilizing and securing the damaged tower, and building a temporary structure to support the conductors until a new permanent structure can be erected. For the temporary
